## **Reserve Manager's Monthly Report**

**May 2021**

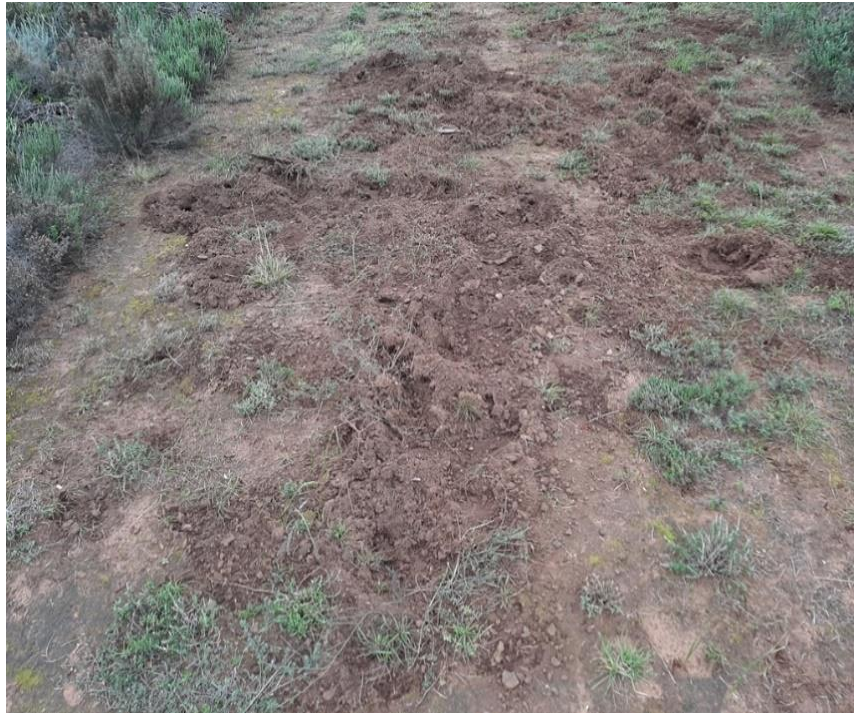
- We have noted during our weekly beach clean ups that the beaches have way less pollution and rubble than in previous months. May this trend continue.
- It appears that a bushpig excavated areas along our internal firebreak just west of pumpstation No4.

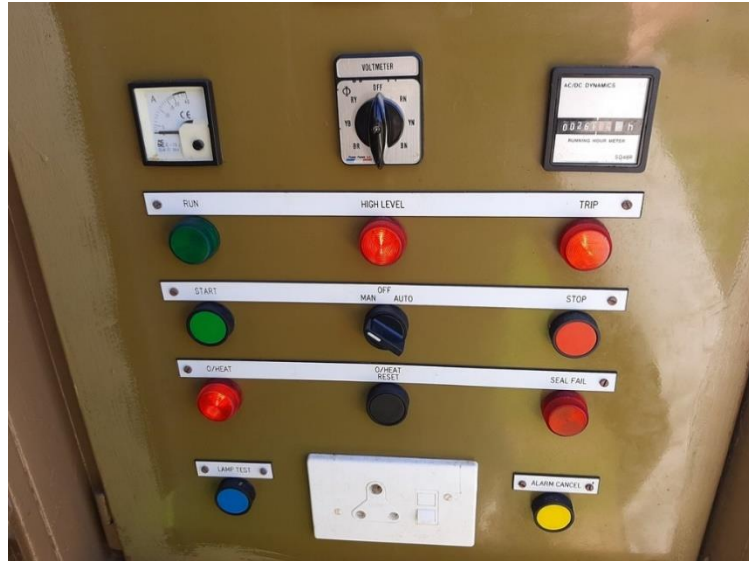
- I continue to inspect all the pumpstations, sewerage plant and internal firebreak weekly. On 11 May, pumpstation No 4 had its high level, overheat and trip lights illuminated, and the pump was not running.

- 
- The sump could not be emptied manually, even after all the circuit breakers were reset. The overheat light remained on. We managed to empty the sump by manually by depressing one of the relays. During this process we noted that the pump was also pulling too much power. The fact that the overheat light stayed on indicated that one of the pump's seals had probably blown. There are two pumps in the store which we plan to test. If one of these pumps are operational, we will replace the broken pump and then have that sent off to be repaired. On the same day I observed that at pumpstation No 3 some of the circuit breakers had tripped. I reset all the circuit breakers and was not able to manually pump the sump empty. We then discovered that three fuses had blown. Once these were replaced, we manually emptied the sump until the bottom float switch was activated to switch off the pump. The two other pumps were found to be working normally.

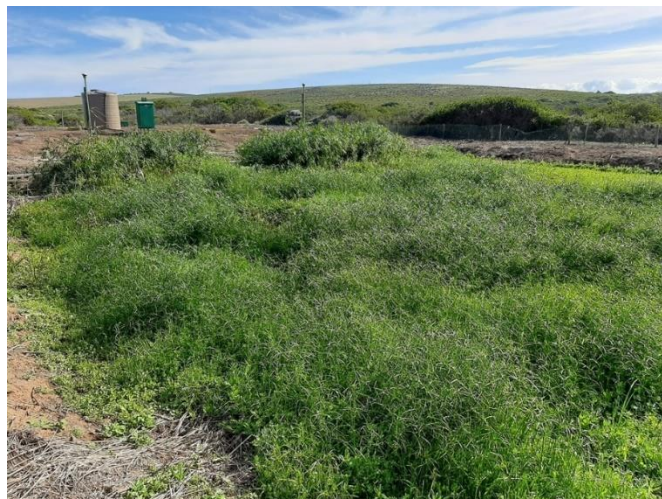
- At the sewerage plant all appears to be in order and operating as expected. We seeded the plant twice during the month with bio-enzyme granules and once with chlorine tablets. We have noted continued growth of reeds in the cleared areas with almost 50% of the cleared area now covered in new growth. This growth of reeds is taking place in the areas as per the engineering design drawings.

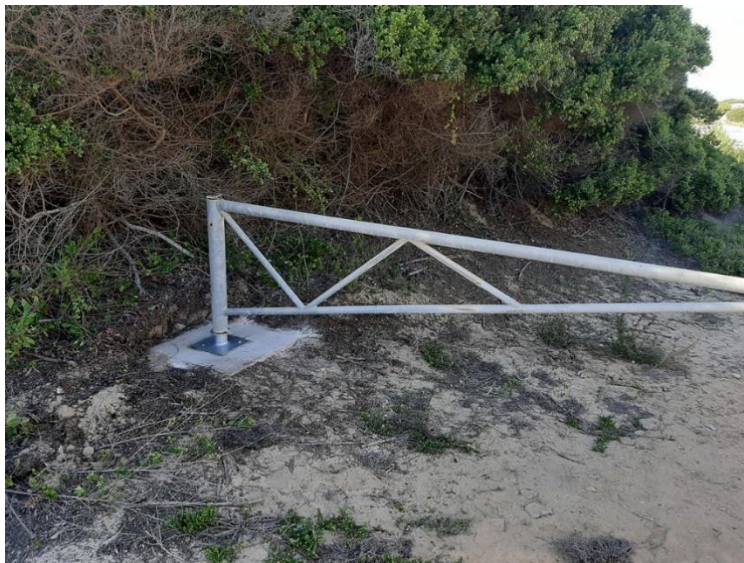
- ATS was on site to repair the faulty controller in the guard room and the beam on the western beach road.
- The boom at the Western beach entrance was repaired and re-installed. The old baseplate had to be cut away as it had rusted through.
