## **Estate Manager's Report - January 2021**

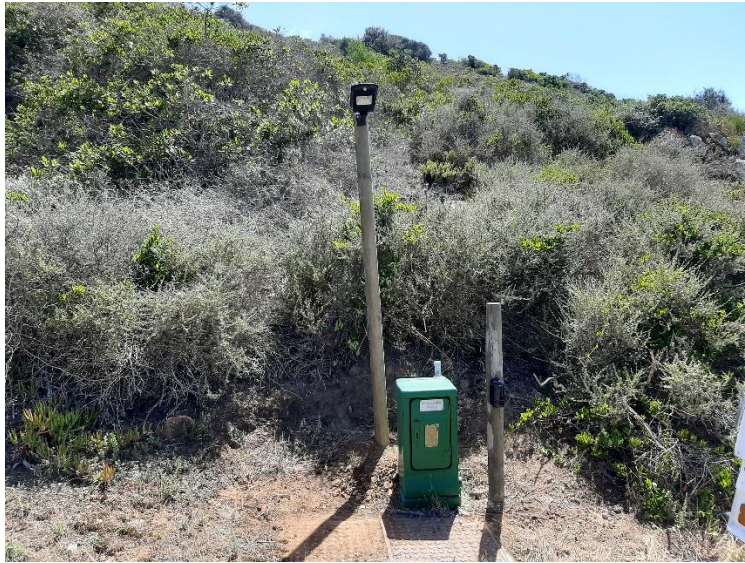
- Solar lights with motion sensors and day/night switches were installed at both of our beams and along the beach roads to provide additional lighting specifically at the beam areas when they are triggered at night. This will allow the guard on duty to better observe what has triggered the beam during night shift.

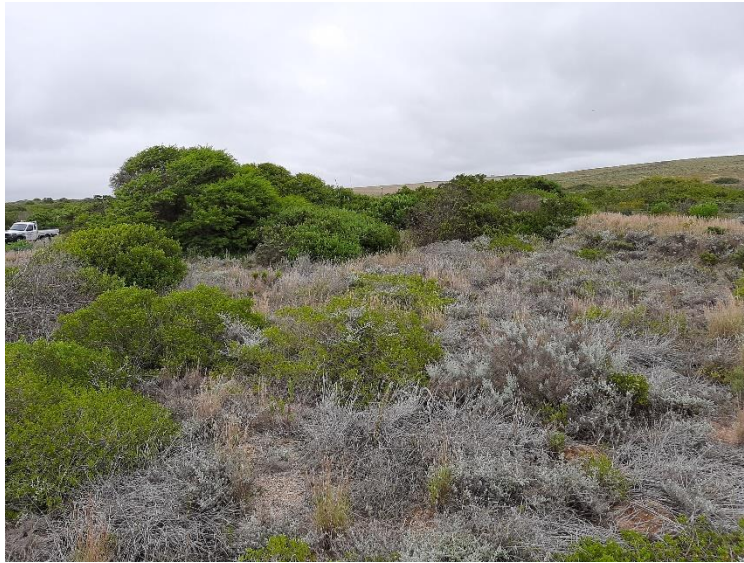
- During my first routine inspection I observed that some of the “Super Sewer” sumps at the sewerage plant were overflowing and that the level of liquid effluent in the soak away dam was higher than normal. I was informed that higher volumes in the system due to the holiday season could account for this and that something similar had been observed the previous year. This appeared odd given the fact that the Estate was only 40% developed. On further investigation it was observed that almost 75% of the soak away dam was bone dry and that only the first quarter had reeds growing in it.

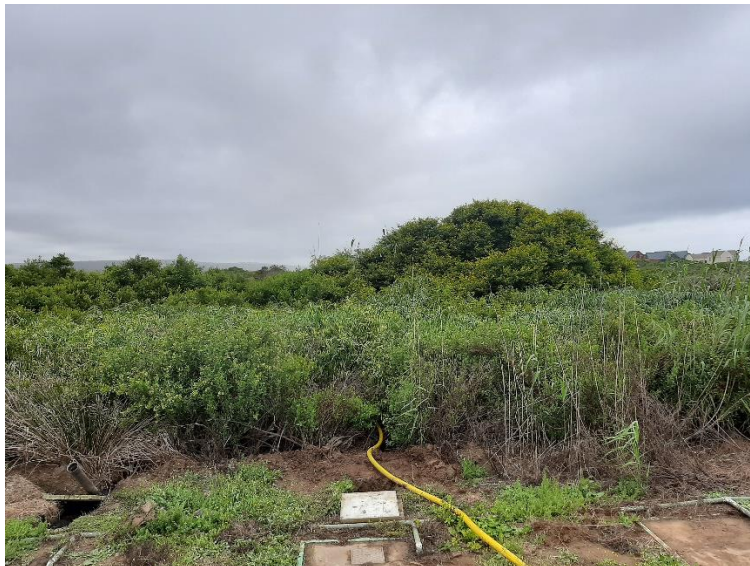
Clearly the system was not operating as it should. To rule out any blockages the outflow pipes were lifted. It was discovered that some of the reducer connections were broken. These pipes were rodded and no blockages within these pipes were discovered. New reducer connections were installed. Two of the sump walls had to be demolished as the reducers were built into the walls. During this operation, the sumps were pumped empty and it was noted that effluent drained from the soak away back into the sumps. Clearly the reedbed was choked and effluent could not soak away as it should. Kobus Steyn arranged for engineering drawings to be obtained. According to these drawings the first 3 metres of the soak away are supposed to contain crusher and only reeds other side the block wall located at the 3m mark. The entire western side of the soak away is currently covered in reeds and weeds.

A trench will now be excavated from the edge of the soak away up to the block wall. This will indicate the condition of the crusher and the impact of the reeds and other weeds in this area. The incline of the outflow pipe will also be determined because of the ingress of effluent from the soak away into the sumps that was observed. Once the trench has been excavated, we will most likely have to remove all the reeds and weeds in this first section and ensure that the block wall is not clogged up. We will

also have to ensure that the liquid effluent flows through the block wall into the reedbed area, which is underlain by coarse river sand, thereby utilising more of the soak away, as it was originally planned. We have also seeded the plant with Bio-enzyme granules twice this month to aid with the break down of the sewerage.

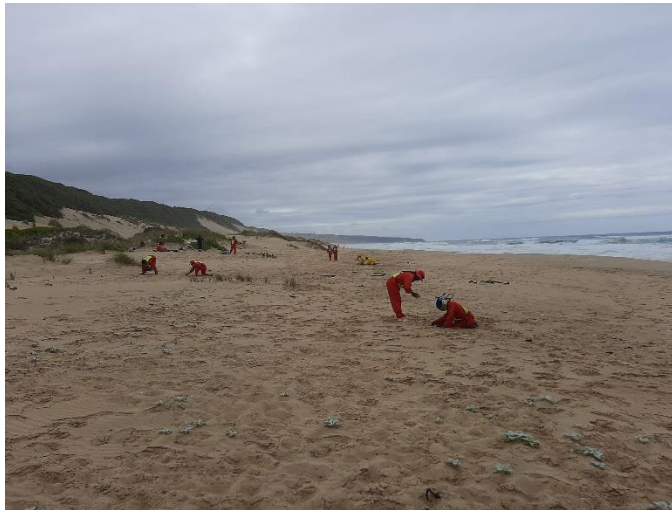
- The water troughs located at the pumpstations were all cleaned and filled with fresh water. These areas were also sprayed for weeds.
- We clean the area at the N2 Vleesbaai turn off every 2 weeks.
- The beach is cleaned every Friday morning. On our first beach clean-up for the year, we collected 5 bags full of water bottles, cooldrink cans and empty beer bottles. These did not originate from the ocean but were left on our beach by our residents, their guests as well as fisherman. It is disheartening to see how we soil our own piece of paradise.
- Spilltech cleaned the beach area adjacent to Nautilus Bay from 8 to 12 January. Their main aim was to remove the spillage of nurdles in the vicinity of the high water mark.

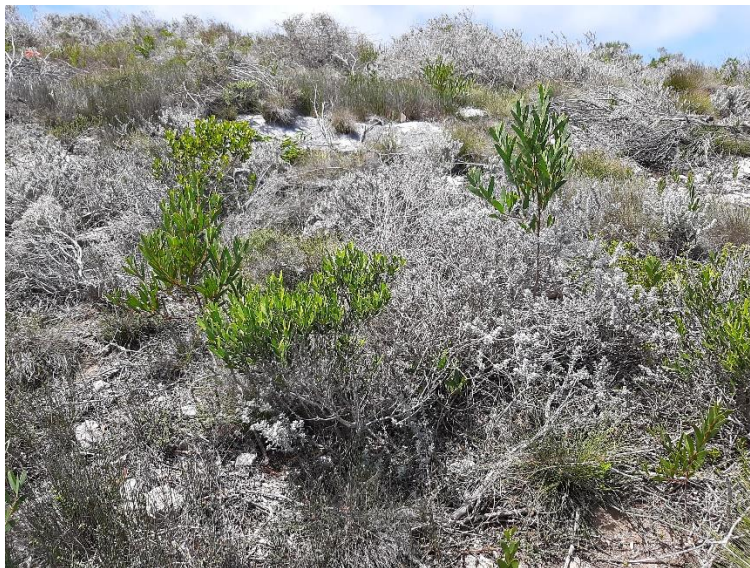
- Pockets of Rooikraans regrowth have been observed in the residential area inside the internal firebreak. The amount and speed of the re-growth is staggering and will have to be constantly monitored and actioned. Our aim is to remove all cuttings and to stop the practice of leaving the cuttings where they fall.

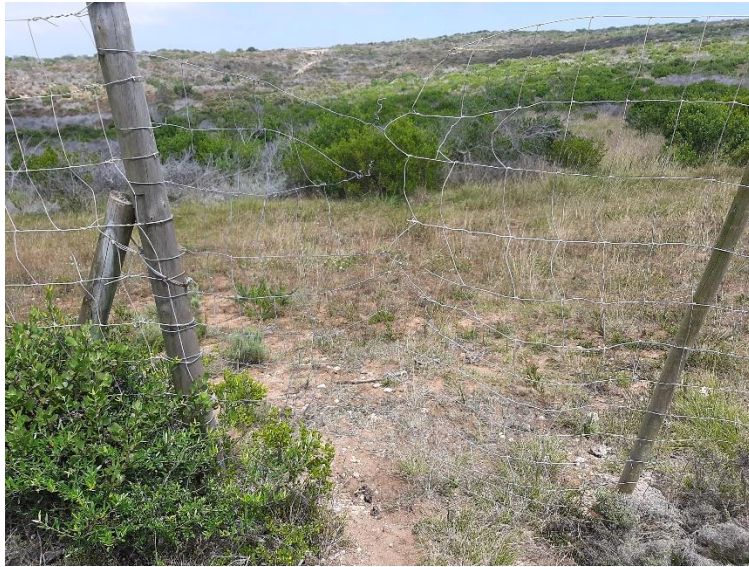
- I believe we will require assistance to tackle the eradication of the Rooikraans in our Reserve area. Charl Wade from Working on Fire will be on site in February to do a site inspection and provide us with a quote.
- A meeting has been set up with Erich Goold from Fransmanshoek Conservancy to establish closer working relationships and to also seek his perspective on how best to tackle the Rooikraans infestation.
- On a recent inspection of the Western boundary fence, it was noted that the two track path running through our reserve area is badly overgrown. This will have to be cleared. The Western fence itself has been compromised at two locations. According to our workers these were used in the past by the Rooikraans eradication teams, who obtained access from the neighbouring property. These sections of fence will have to be repaired. Access to this area however remains a challenge.

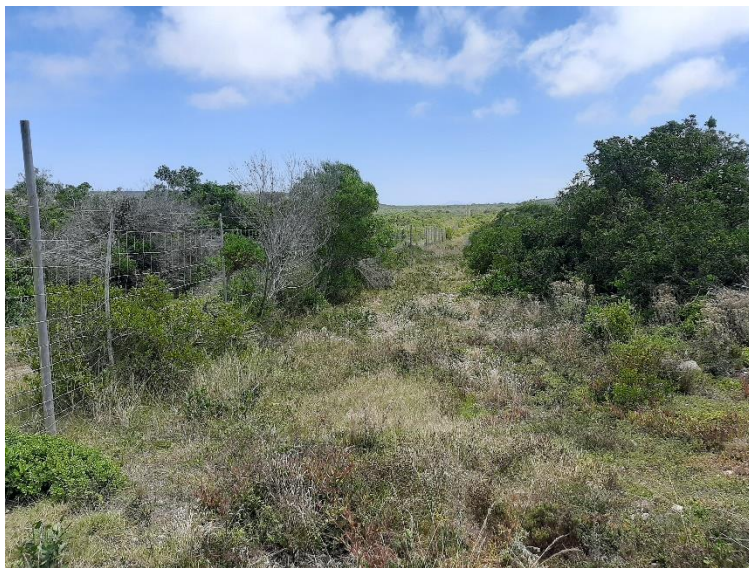
- Our perimeter firebreaks along our western and northern boundaries are also badly overgrown in areas. It is clear that these have not been serviced in years. This too will require attention.

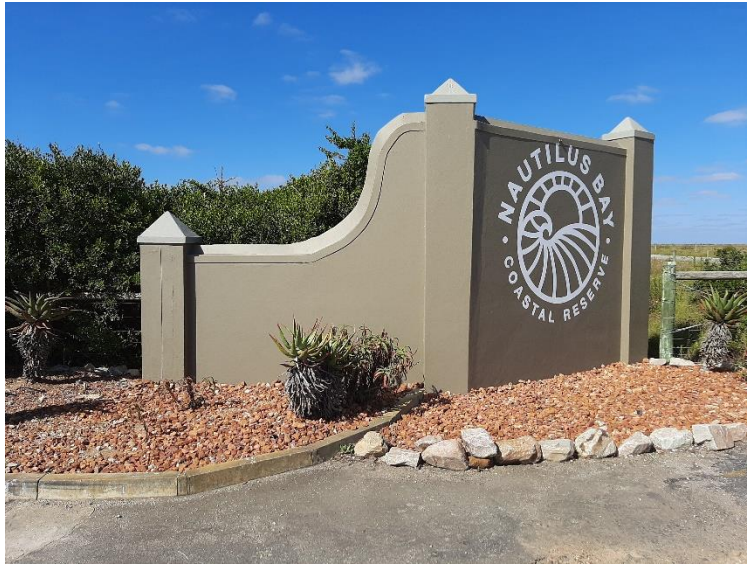
- **Roads:** The sealing of the cracks on the first 200m of the main entrance road were completed in 2020. The remainder is still outstanding and will be undertaken as soon as work at the main entrance is complete. This task will take at least two full weeks to complete.
- **Fleesbaai Entrance:** Final plastering of the one remaining pillar at the main entrance was completed. This has now also been painted. The flowerbeds will receive a facelift during the cooler, wetter winter months.

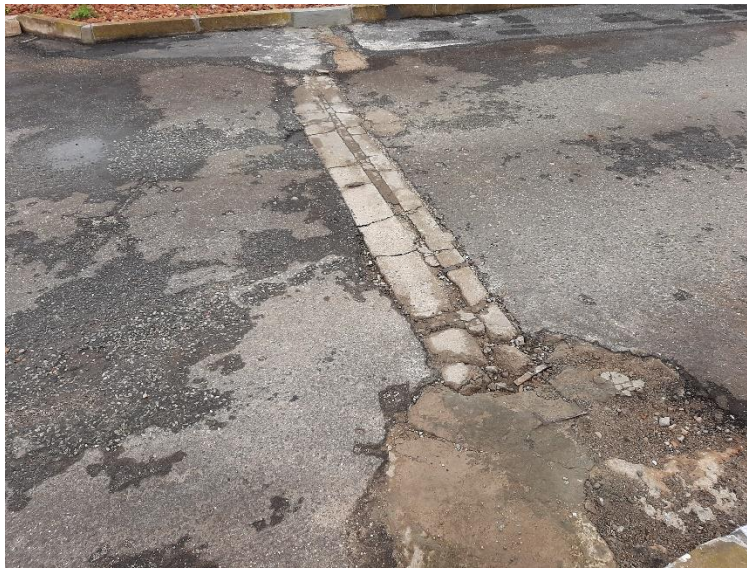
The concrete strip that housed the old rail for the original entrance gate will be removed and replaced with tar this coming month. The potholes at the entrance will also be repaired as we now have space to close off half the entrance at a time.

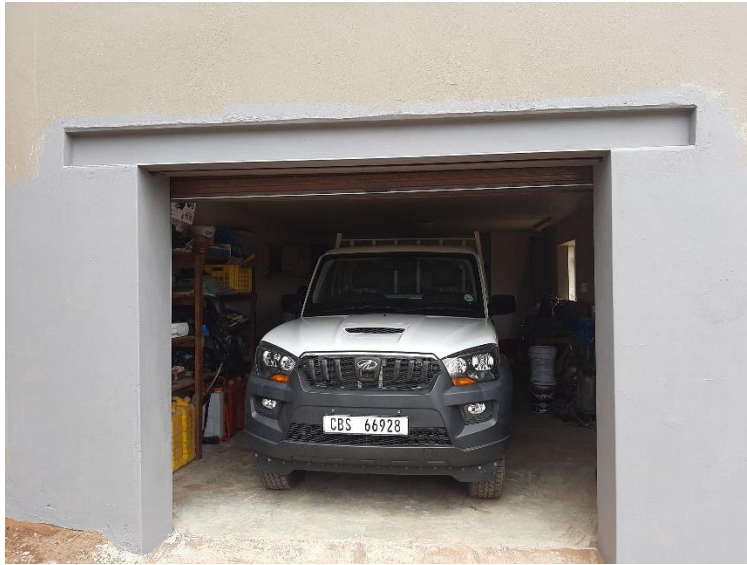
- **Office upgrade:** The remaining flashings were sealed on the office roof. No obvious roof leaks were observed after some light rain. The account for the roof repairs will now be settled.
- The live cable located outside the main entrance island was shortened and joined and is now out of harm's way. The wall on the inside of the main gate will be removed during the coming month to further improve visibility at the main gate area.
- **Flags:** Unfortunately, the Nautilus Bay flags that were collected on 22 December, were not as specified. These then had to be returned and we are expecting delivery the first week in February.
- **Garage conversion:** The Estate bakkie is now housed inside the storeroom after hours and over weekends. This was finally made possible after the driveway had been sufficiently excavated.

The beam filling in between the I beams is still outstanding. The affected areas have been painted with Elastocryl undercoat and only the final coat is still outstanding.
