# **Reserve Manager's Monthly Report**

**September 2022**

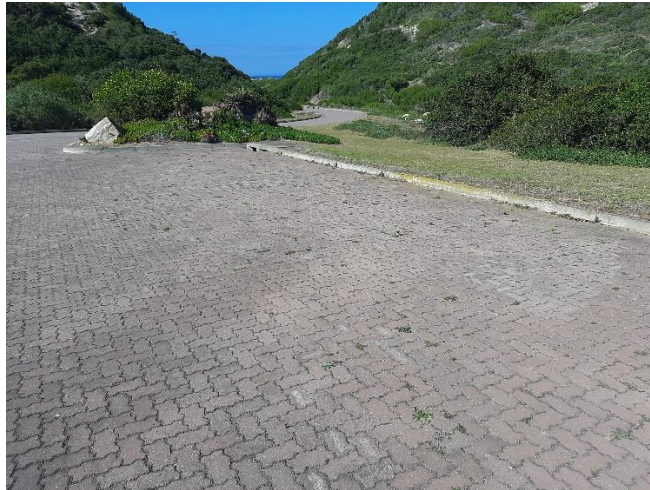
- Vervet Monkeys were also observed along the northern boundary fence adjacent to our main entrance.
- The area at our Western beach road parking area we used to test the acid-based weed killer is full of weed again, so clearly not a suitable alternative. Our knapsack sprayer did not take kindly to the acid-based substance, with some soft plastics showing signs of decay.

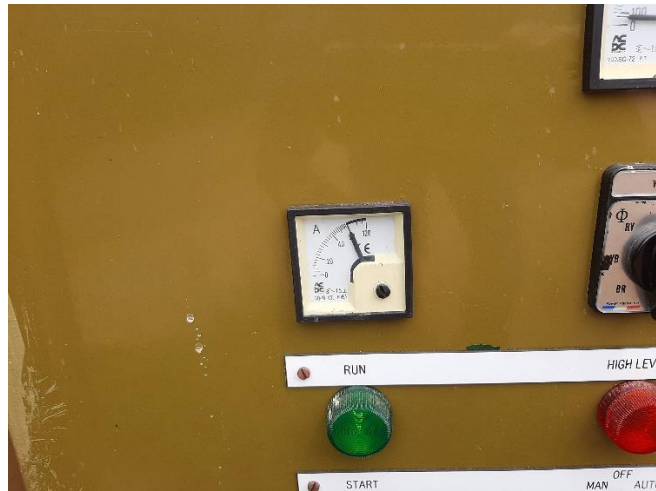
- I observed that Pumpstations 2, 3, and 4 peak at 15A during start up and then run at around 6 to 8A. Pumpstation No 1 peaks at 60A and then runs at 20A.

- These numbers mean that the three smaller pumps could be run using a 12.5Kva 3 phase generator, but that the bigger pump would require a 24Kva 3 phase generator. This larger generator would cost around R150000 and can weigh up to a ton. Certainly not portable. A smaller 12.5Kva generator could handle the three smaller pumps at a cost of R36000. This generator is classified as portable and could be loaded on the back of the bakkie. We will investigate if there are solar options to supply power during prolonged periods of power outages caused by cable theft or load shedding.
